STATE OF CALIFORNIA
DEPARTMENT OF TRANSPORTATION
DIVISION OF FACILITIES CONSTRUCTION
OFFICE OF TRANSPORTATION LABORATORY
and

EFFECTIVENESS OF RUBBERIZED ASPHALT
IN STOPPING REFLECTION CRACKING
OF ASPHALT CONCRETE
(Interim Report)

1. REPORT NO. FHWA/CA/TL-85/09		2. GOVERNMENT ACCESSION NO.		3. RECIPIENT'S CATALOG NO.	
4. TITLE AND SUBTITLE EFFECTIVENESS OF RUBBERIZED ASPHALT IN STOPPING REFLECTION CRACKING OF ASPHALT CONCRETE (Interim Report)				5. REPORT DATE January 1985

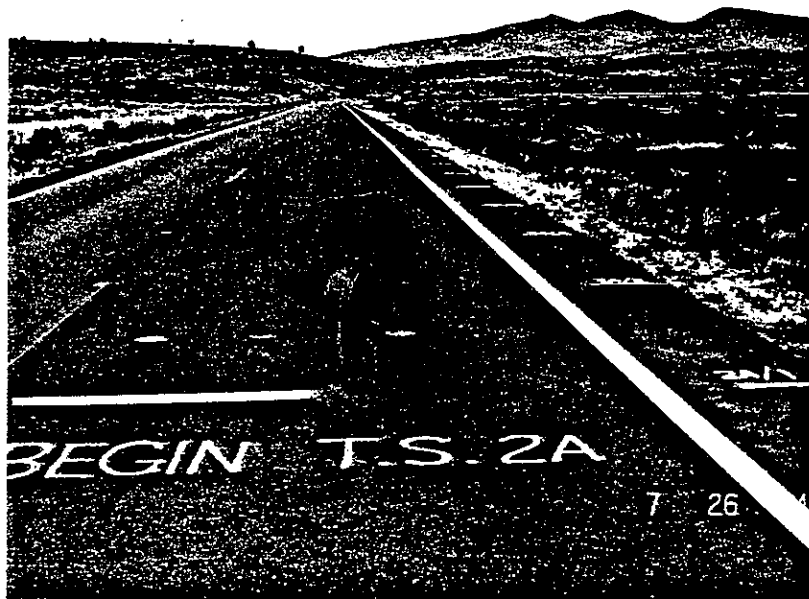
Photo "Hash" Marks on Pavement
Figure 3

Each test section was laid out on the pavement and divided into 20 equally-spaced picture points (PP), each delineated by a "hash mark" painted on the paved shoulder and numbered so as to label and identify each photograph (Figure 3). The ends of each test section were referenced with steel survey pins set outside the planned limits of work to allow the test sections to be retraced exactly on top of the overlay after completion of the project.

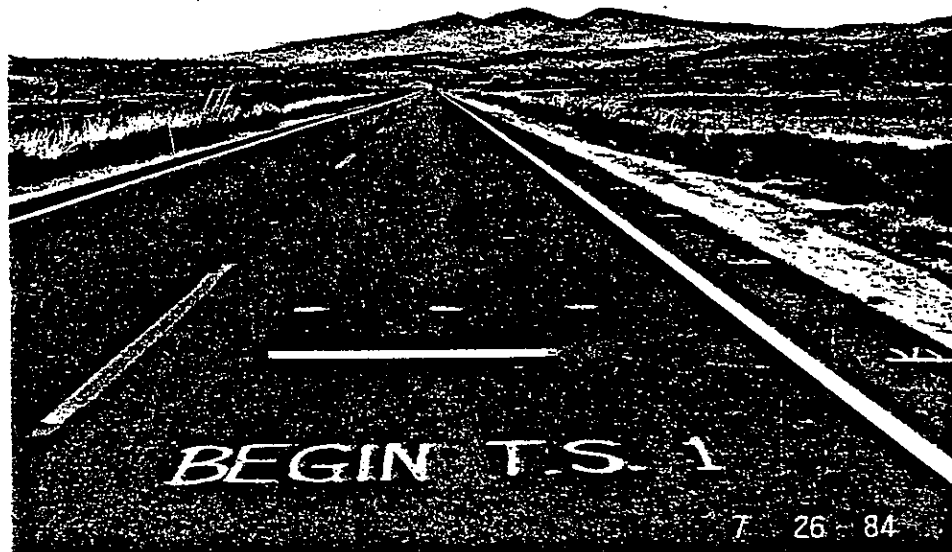
Figure 8

ARS Mix - P.M. 92.26

ARS product (Figure 8) can be produced by a dryer-drum plant equally well, though with the same need for an adequate rate of

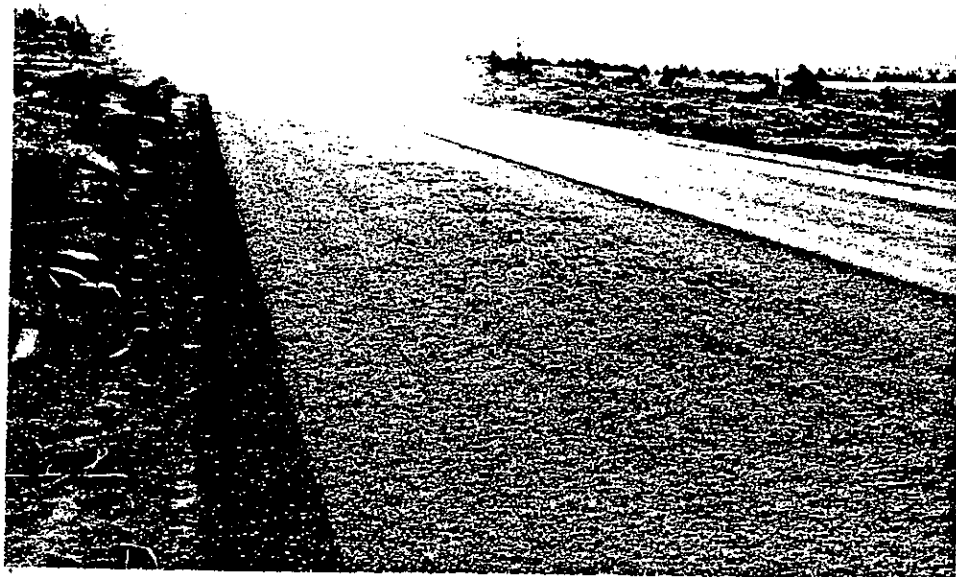
Figure 9

PlusRide Mix - P.M. 97.66

The PlusRide product (Figure 9) placed in Segments 4, 5 and 6 is another rubberized DGAC. It contains larger rubber particles as part of the dry aggregate. This requires that the mineral aggregate be "gap graded". This is often difficult to do, and on this project, considerable waste was generated in attaining the gap grading. The final aggregate gradation, however, was still somewhat deficient in the passing No. 200 fraction (after processing to a gap grading, only 5.0% passing No. 200 was available). All Seasons representative Bob Linden ultimately established that with the addition of 4.7% pozzolan, the required grading (8% to 12% passing the 200 screen), could be achieved.

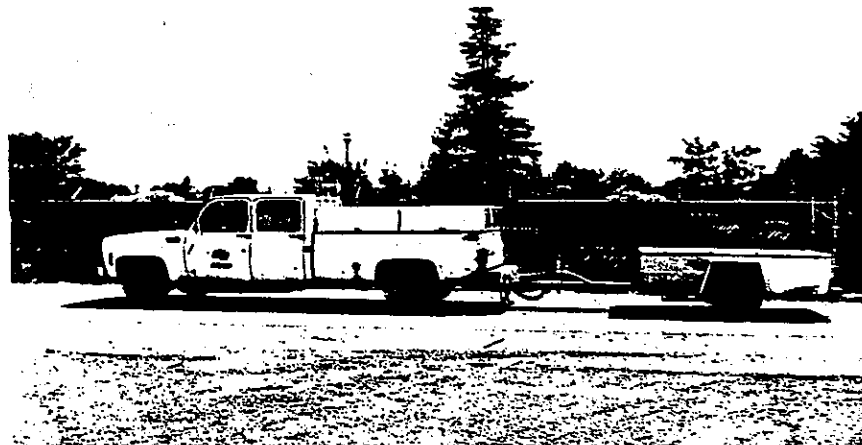
Towed Trailer Skid Tester
Figure 11

In October of 1983, skid tests were run on each of the 15 test sections using the Towed Trailer Skid Tester (Figure 11).

The conventional DGAC in TS 7 through 10 had exceptionally high skid numbers (SN 40), averaging 66.5. The ARS-DGAC in TS 2 through 3 had good skid numbers, averaging 55.5. The PlusRide DGAC in TS 4 through 6 had adequate skid numbers, averaging 40.5. The rubberized chip seals in TS 11, 12 and 13 had very good skid numbers, which averaged 59.3 (Table 5 - Column 8).

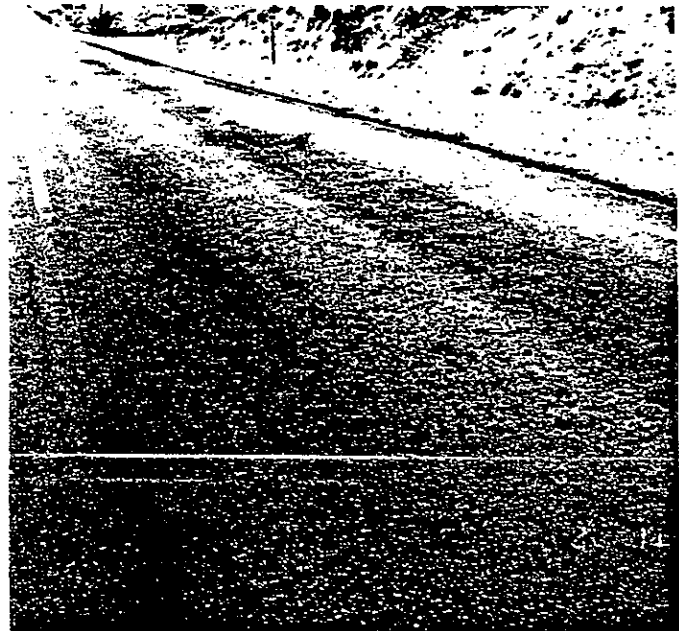
Figure 13

DGAC (Seg. 8)
Cracking

By the end of January, a report of pavement cracking on the project was received. In early February 1984, a project review disclosed considerable loss of surface fines, especially in the wheel tracks, in Segments 7 and 8 (0.20' and 0.18' conventional DGAC [Figure 12]) and fairly severe cracking in the southbound lane of Segment 8 (Figure 13) across the road from TS 8 . One longitudinal crack in the outside wheel track was over an inch wide, and the surface texture had become very coarse. The major transverse cracks were about two feet apart for 300 or 400 feet along the lane, and longitudinal cracks were well developed in the outer wheel track and along the centerline. Oblique photographs were taken to provide a record of the condition at this time. Segments 9 and 10 (0.30' and 0.50' conventional DGAC) showed a slight loss of surface fines, but no cracking.

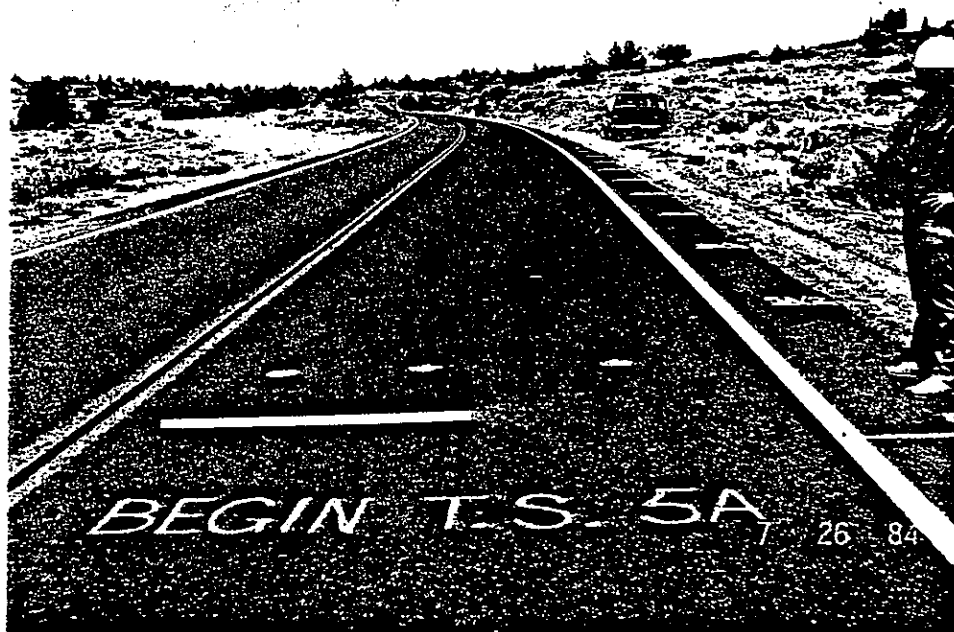
Figure 18

On July 26, the various mixes were also checked for rutting (Figure 18). The maximum measured was about 1/4 inch in TS 10, the 0.50' thick conventional DGAC control. TS 9, the 0.30' DGAC control, and TS 8, the 0.20 DGAC control, showed about 1/8 inch of rutting. The other test sections showed no rutting. The allowable construction tolerance transverse to highway centerline is 0.02 foot (about 1/4"). The depressions measured were all in the wheel tracks.

Checking for Rutting (PlusRide)

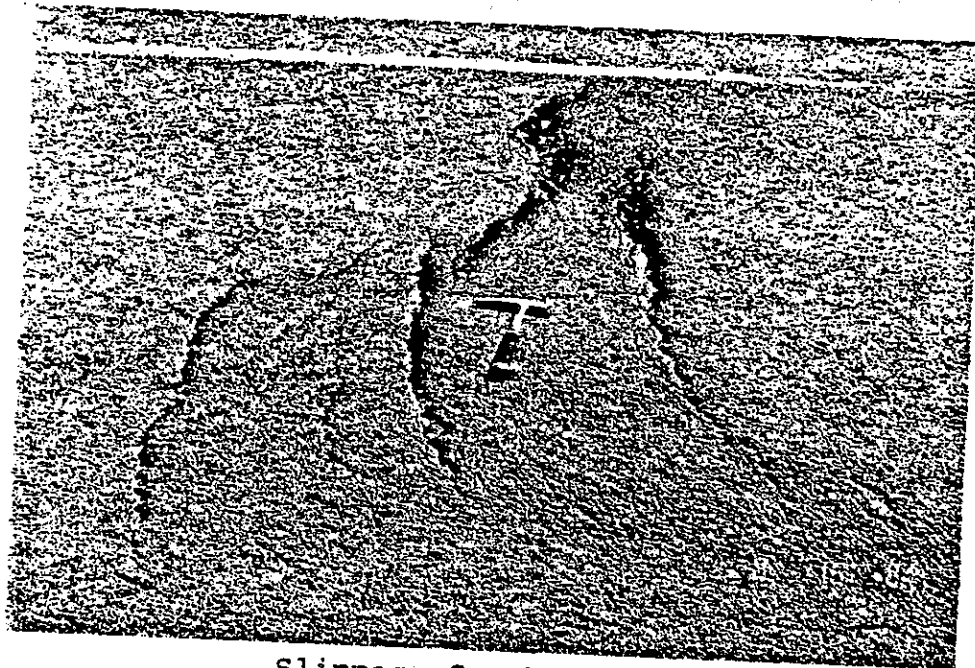
Figure 19

Slippage cracking has occurred in the southbound lane of Segment 8 (DGAC) at P.M. 98.55. A crescent-shaped crack was visible that measured 1-3/4 inches wide and extended transversely across both wheel tracks (Figure 19). It was convex to the south, downhill, and was apparently the result of vehicle braking on a poorly bonded surface course. Farther south (20' to 30') are several much smaller transverse surface "tears", each about 1/2 inch by 3 feet. They are about 20 feet apart and are in the outer wheel track. There was no sign of this problem elsewhere on the project.

Slippage Crack (DGAC)
